B4102 Blossomfield Road (Tudor Grange Leisure Centre to Widney Lane)

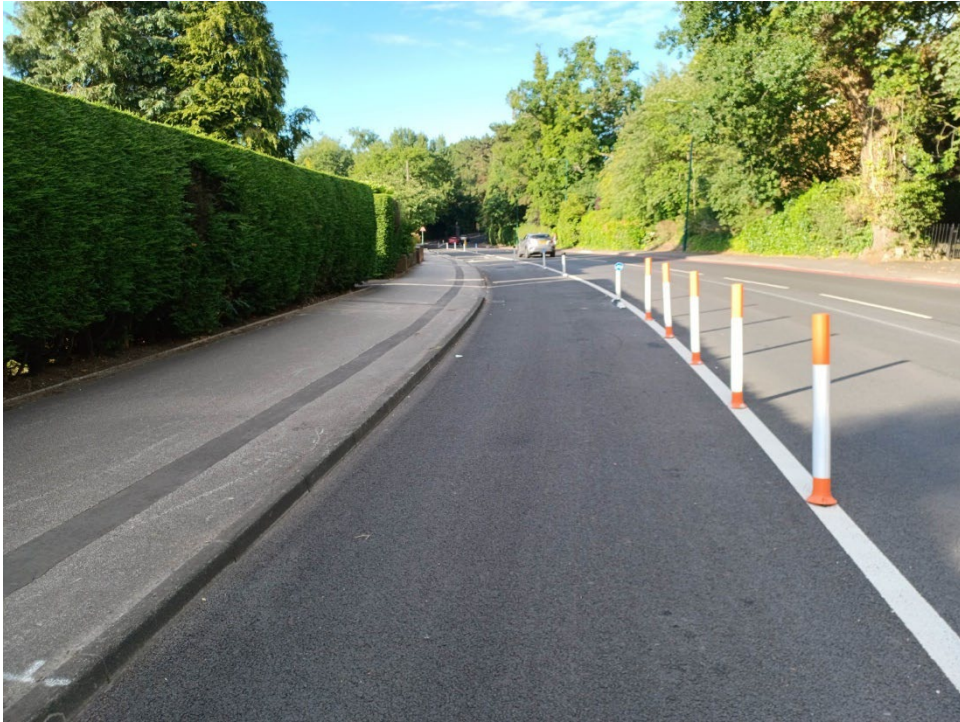
- 1.4 As part of Tranche 2, a dual cycle lane was implemented along the south-bound carriageway of Blossomfield Road from a position approximately 70 metres north of the Longmore Road/ Widney Lane/ Blossomfield Road/ signal junction continuing in a northerly direction to the junction of Dorchester Road with Blossomfield Road a distance 1.9km. The cycle way measures between 2.5 and 3 metres in width and is supplemented throughout with light segregation measures (Orcas and Wands) and road markings, in addition to raised tables provided at each bus stop location along the

route to facilitate safer cycling and pedestrian accessibility.
