## **B4104 Birmingham Road (Millisons Wood to Meriden)**

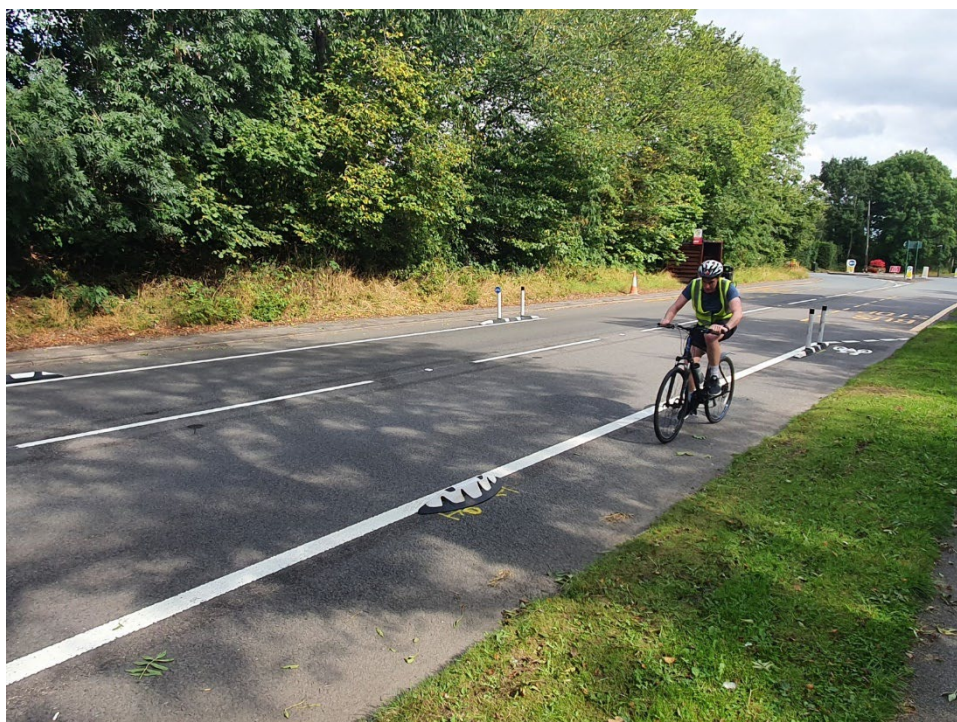
- 1.1 The scheme starts in Millisons Wood and follows the B4104 Birmingham Road into Meriden Village Centre. The scheme was initially designed at the request for the community and the Parish Council as a school bus service no longer operated and the new facility would provide an option to travel more sustainably. The previous on-carriageway cycling provision was narrow and unsegregated, encouraging high vehicle speeds and acted as deterrent to cycling.
